Date: April 26th

SUBJECT: AcuraWatch™ 360 Bumper Cover Repairs

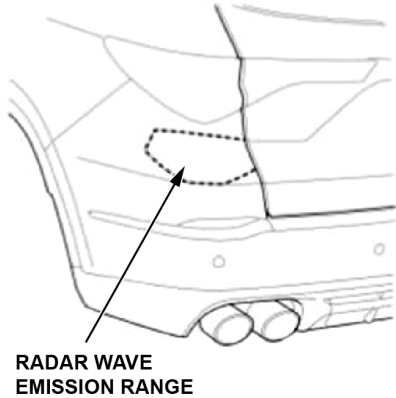
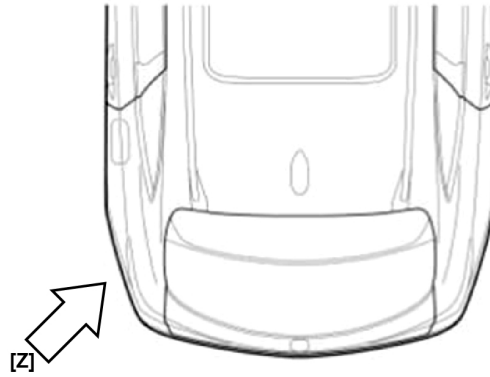
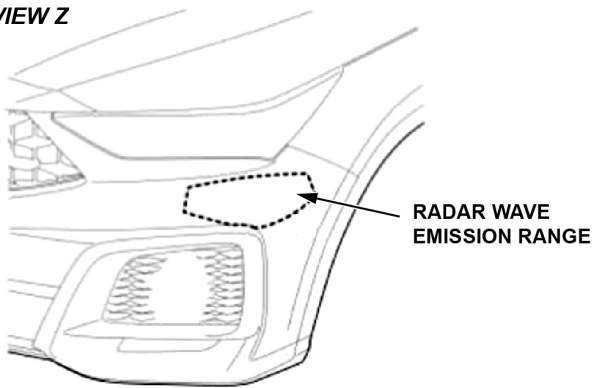
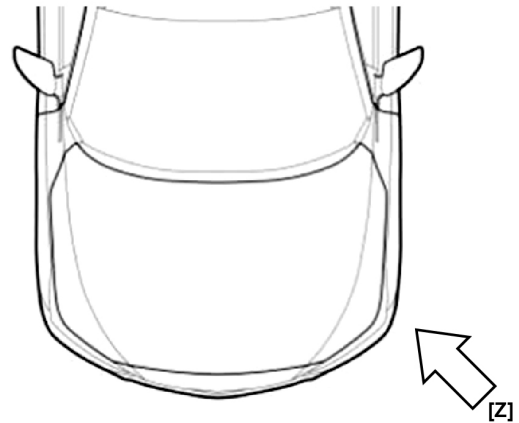
Location Examples of Radar Wave Emission Ranges

Damage or partial coating within the radar wave emission range of the bumper equipped with the radar unit may interfere with its operation, so refer to the table below to determine whether to repair:

Damaged Condition	
		Crack, Dent, or Gouge	Paint Scratches
Damaged Area	Within Radar Wave Emission Range	Cannot be repaired	Can be repaired only by sanding the entire radar wave emission range
	Out of Radar Wave Emission Range	Can be repaired, however if some of the refinishing material crosses into the radar wave emission range, then the entire radar emission range should be refinished. Do NOT blend in the radar emission range area.*	Can be repaired, however if some of the refinishing material crosses into the radar wave emission range, then the entire radar emission range should be refinished. Do NOT blend in the radar emission range area.*

If damage reaches the material on the front or back side of the bumper radio wave emission range, the bumper cover will need to be replaced with a recommended genuine new part and refinish according to the repair paint manufacturer's instructions.

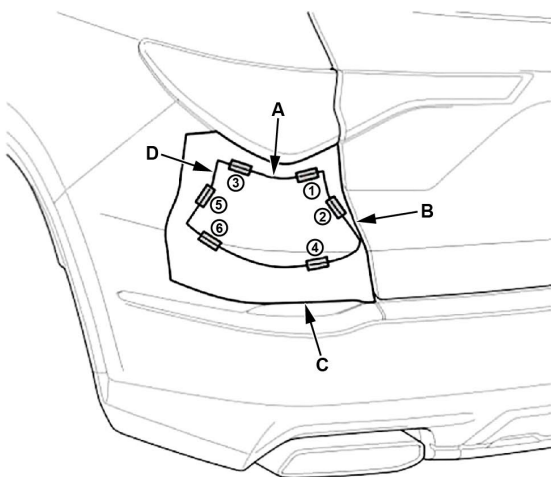
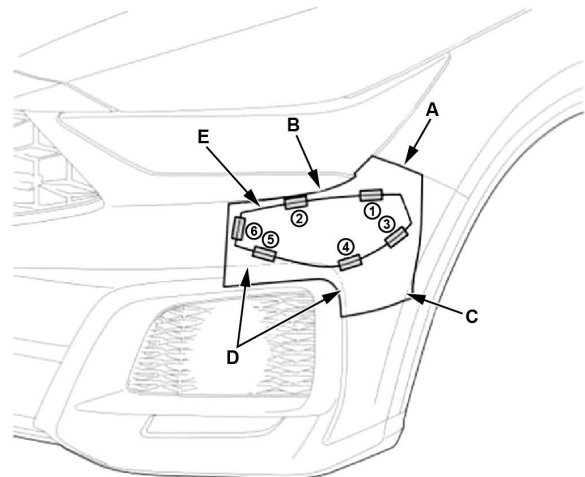
The radar waves passing through the bumper covers are more affected by the type and location of the repair. Cracks or dents within the radar wave emission range cannot be repaired and will require bumper replacement.

To assist technicians in determining where the radar wave emission area is, a printable template is provided in the body repair manual. This template can be taped onto the bumper and will help determine if the bumper can be repaired or will require replacement.

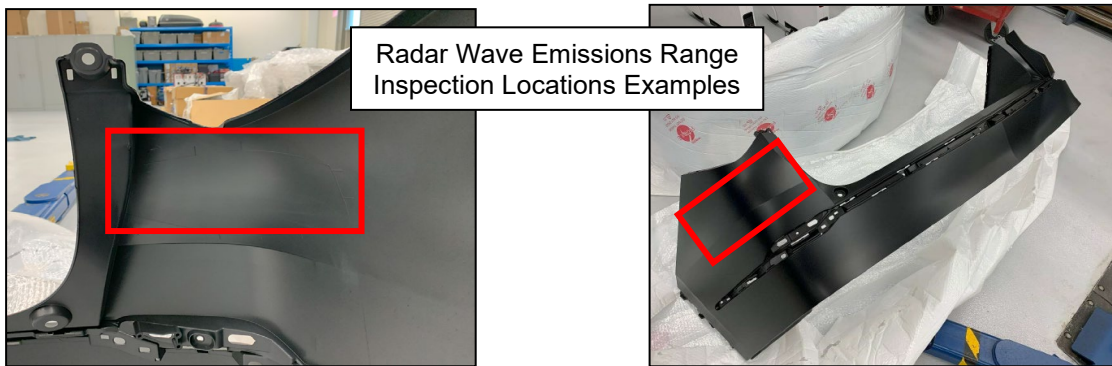
When inspecting a delivered new bumper cover, it is important to inspect the Radar Wave Emission Range areas. If damage to the plastic material of the bumper cover exists within the Radar Wave Emissions Range area, the bumper cover cannot be used.

NOTICE: Do not repair bumper cover when damage is found on the radar wave emission range at receiving and return it to an authorized dealership.
