# Technical Service Bulletin

<b>Subject:</b> <b>MULTIPLE ELECTRICAL MALFUNCTIONS AFTER BODY REPAIR</b>	<b>Bulletin No.:</b> 09-035/18
	<b>Last Issued:</b> 09/14/2018

2016-2019 CX-3  
2013-2018 CX-5  
2016-2018 Mazda2  
2014-2018 Mazda3  
2014-2018 Mazda6

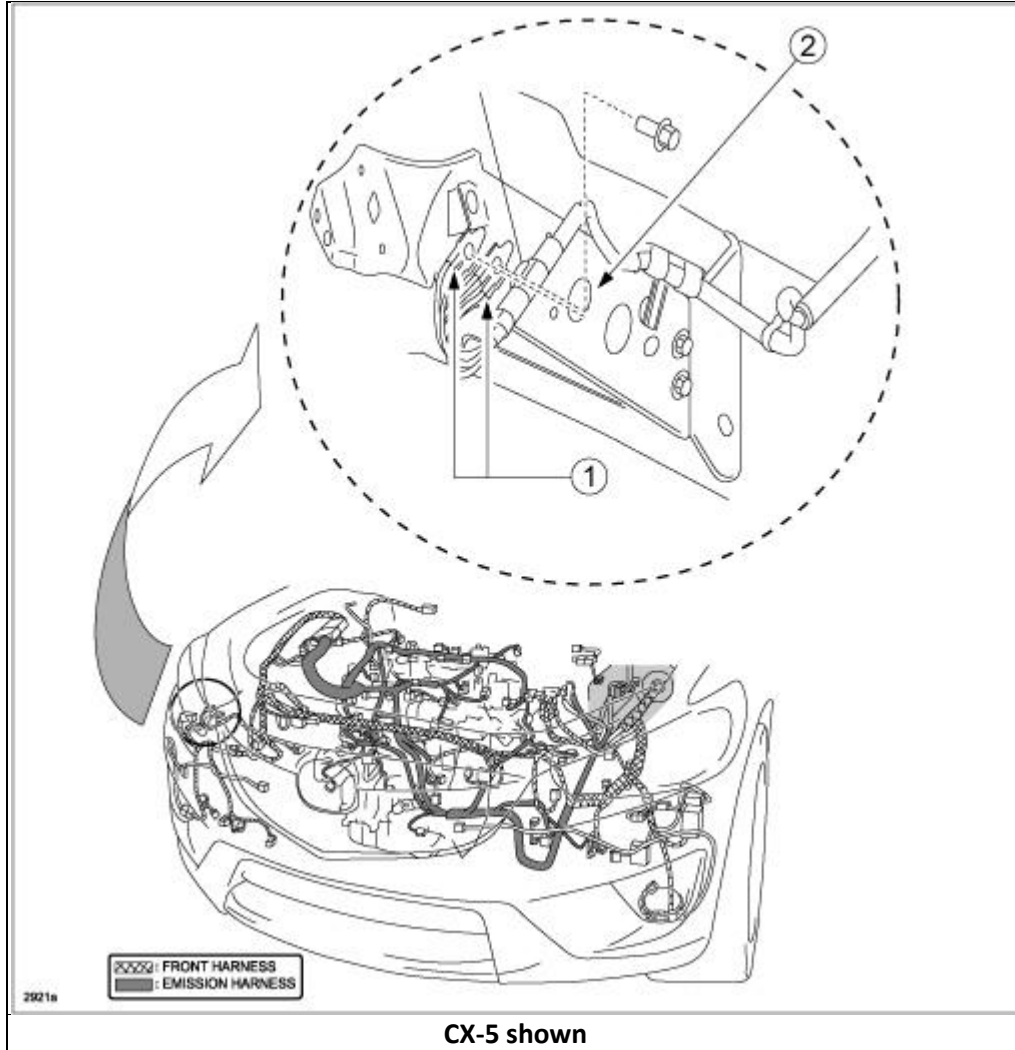
Some customers may experience **one or more electrical malfunctions** after a vehicle body repair. The newly painted fender stay (2) may be causing a poor front harness (1) ground connection.

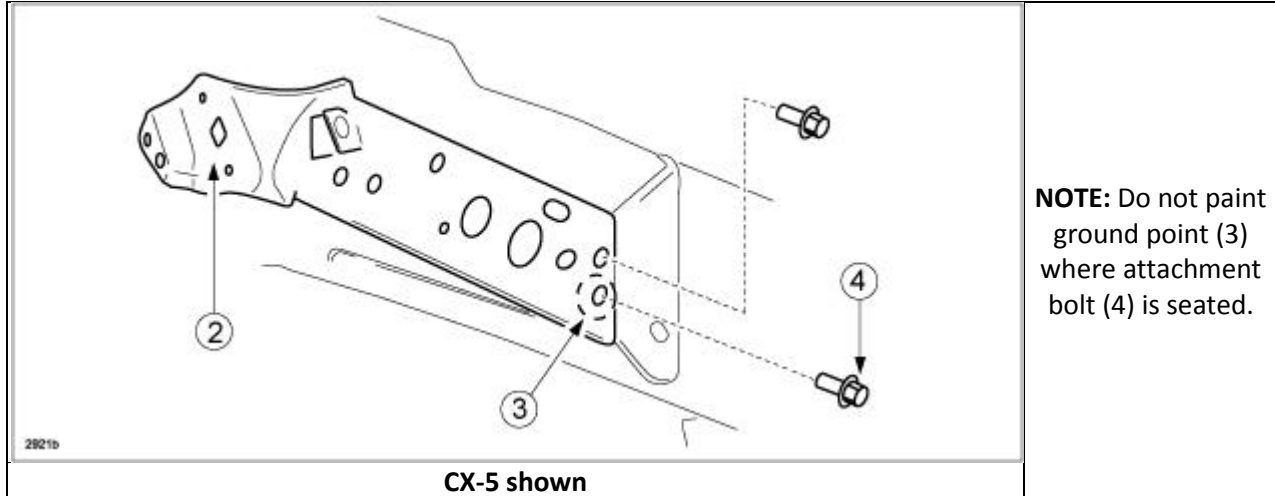
The front fender stay (2) newly painted surface at ground point (3), where attachment bolt (4) is seated, may create a poor front harness ground connection.

Customers concern can be resolved by sanding off paint at ground point (3) where attachment bolt (4) is seated. After installing the bolt (4), apply touch-up paint to the exposed base material area of the front fender stay.

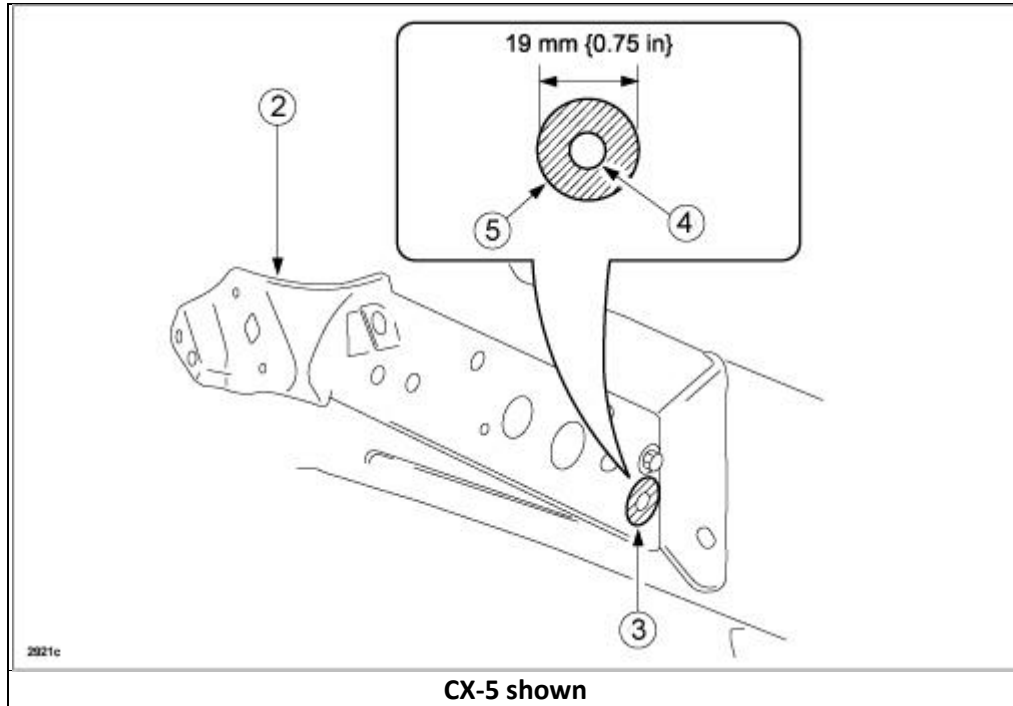
**CAUTION:** If the bolt (4) contact area (3) is painted when the front fender stay (2) is newly replaced, it could cause a malfunction in the PCM. Before painting a newly replaced part, protect the bolt (4) contact area (3) with masking tape (5) as shown in the figure.

**NOTE:** After installing the bolt (4), apply touch-up paint to the exposed base material area of the front fender stay.

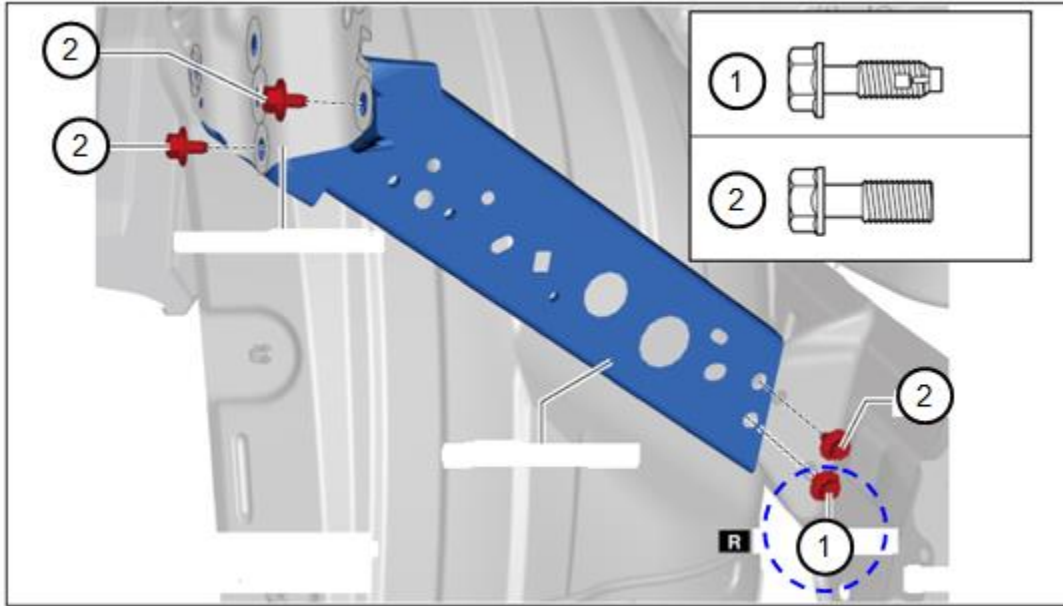
- Ground bolt (1)
- Mounting bolt (2)

**NOTE:** Always replace the ground bolt (1) if the Workshop Manual or Bodyshop Manual instructs to use the ground bolt for proper grounding.
