Date: April 26th

SUBJECT: AcuraWatch™ 360 Bumper Cover Repairs

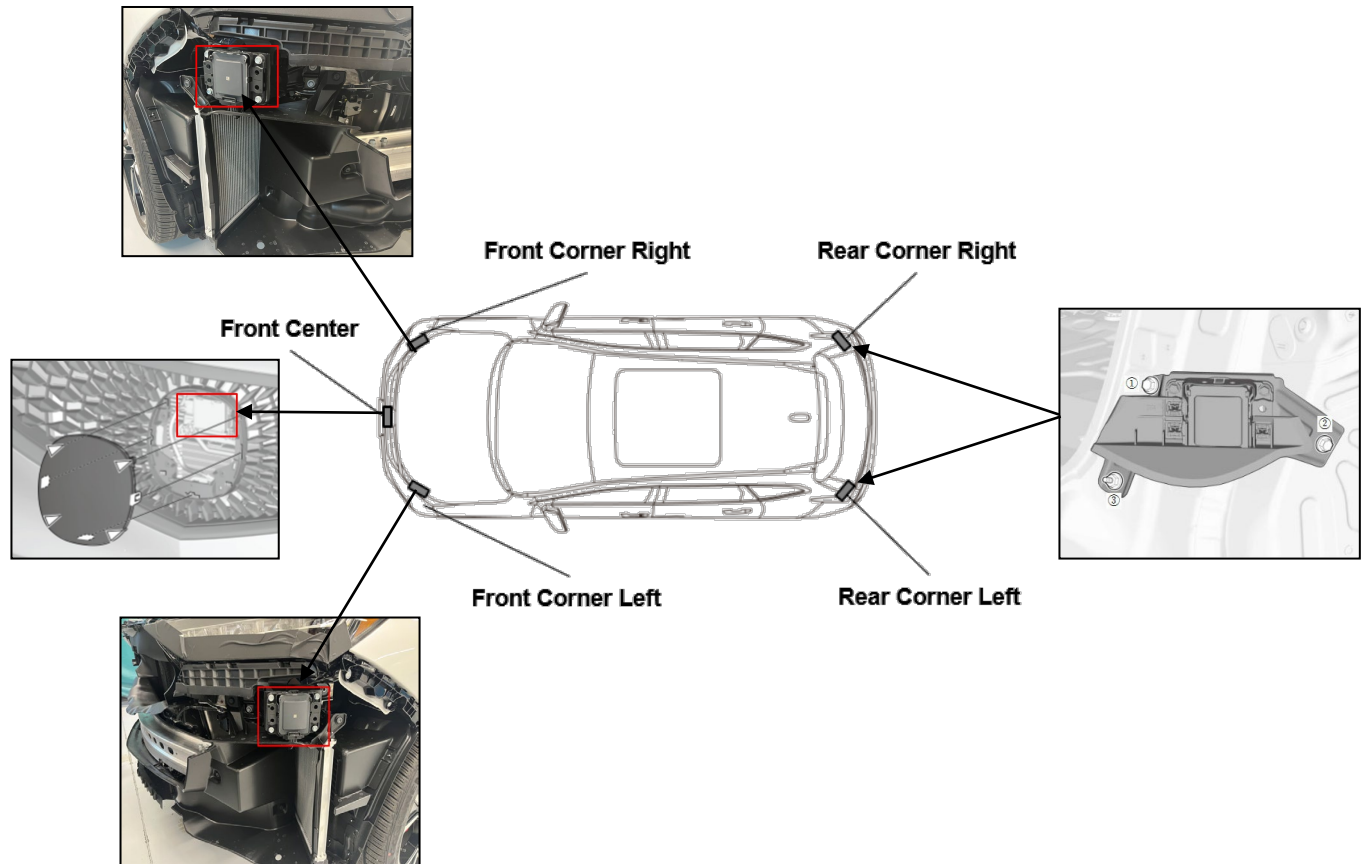
To provide understanding of the possible radar locations, the below diagram may be used as general reference when verifying if a vehicle is equipped with AcuraWatch™ 360 radar units. Radar units may be integrated into the emblem of the front grille assembly in some models.

To locate model specific radar locations, refer to the Visual Index located in the Service Manual.
