## Ford Details Proper Roof Panel Repair (Part 1 – Removal)

This specific vehicle repair—**Section 501-28: Roof Sheet Metal Repairs, Removal and Installation**—is found in the official Ford Workshop Manual, located on [Motorcraftservice.com](http://Motorcraftservice.com).

# Official Repair Procedures: 2018 Ford Expedition Finish-Panel Repair & 2017 Lincoln Continental Head Up Display Module

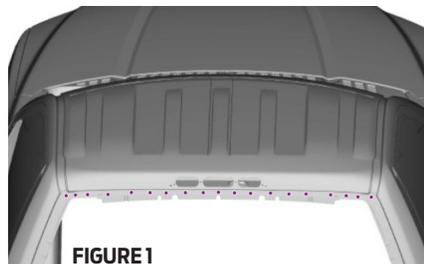
FIGURE 1

Following the workshop manual procedure, the original roof ditch sealer is removed, using a hot air gun and scraper. The SPR rivets at the front and rear of the original roof skin are then removed (**Figures 1 and 2**).

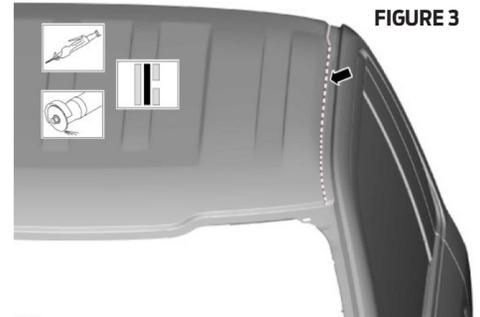
FIGURE 3

The next step directs where to cut the roof (inboard on the roof ditch), noting it must be done to the outer panel only, using the air body saw and spherical cutter (**Figure 3**).

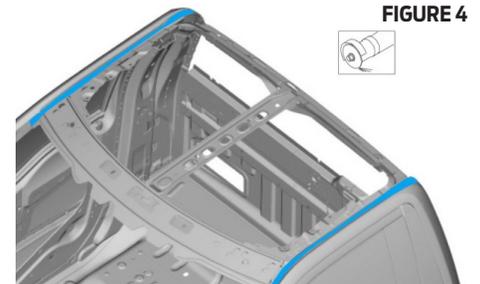
FIGURE 4

Using a grinder or air-chisel, carefully remove the remaining portion of the roof panel flange and laser-weld bead (**Figure 4**). Technicians are strongly advised to use caution to avoid thinning the metal in this area.

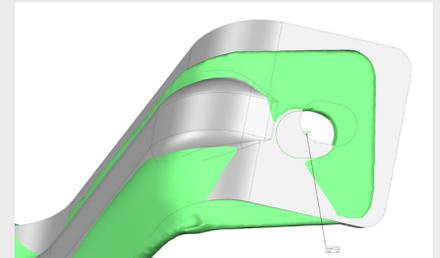
The laser scans show significant deviations from the specifications regarding guide-hole locations and length, as well as fluctuations in the curvature of the bracket wall in numerous locations (green areas).

Ford Motor Company asked an independent test lab to determine whether aftermarket copy versions of F-150 parts frequently replaced in a collision repair would meet Ford dimensional design specifications. The lab conducted laser scans of aftermarket front bumper brackets and a chrome front bumper for the 2012 F-150, and similar to the results of the aftermarket aluminum hood detailed in the last issue of *On Target*, the copy parts did not meet Ford specifications.

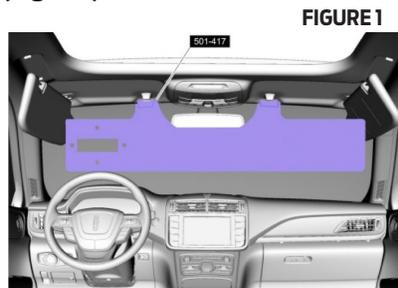
FIGURE 1

5. Install the HUD eye box inside the vehicle. The HUD eye box should be placed on the dashboard directly behind the windshield (similar to how a sun visor would be placed) (**Figure 1**).

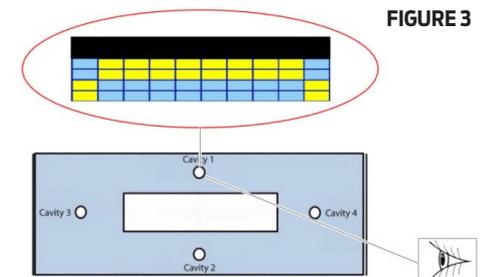
FIGURE 3

8. Adjust the alignment grid, using the UP/DOWN/OK button on the steering wheel, while viewing the grid through Cavity 1 in the HUD eye box until the top two grid lines are not seen (**Figure 3**).

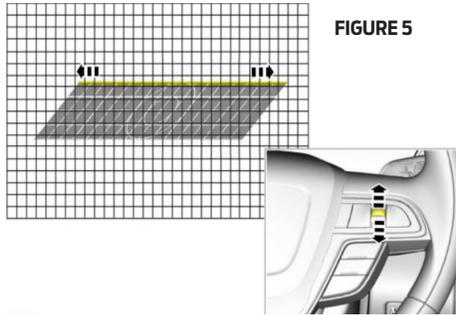
**FIGURE 5**

16. Using the Up and Down button, remove the horizontal distortion from the image (**Figure 5**). Press OK to save the adjustment. Press Return to exit to the previous menu.

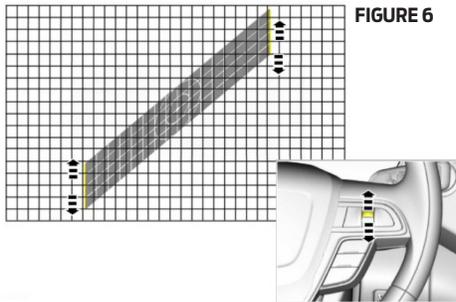
**FIGURE 6**

17. Select Vertical Distortion menu and press OK. Select Trapezium. Determine if vertical distortion is present. If vertical distortion is not present, select OK and skip to step 20.
18. If vertical distortion is present, identify the category of the most severe distortion present in the displayed image (similar to identifying horizontal distortion).
19. Using the Up and Down button, remove the vertical distortion from the image (**Figure 6**), then press OK.
