F-SERIES REGULAR CAB FLOOR PAN INSTALLATION -SERVICE KIT INSTRUCTIONS

SKFL34-1511140-AA

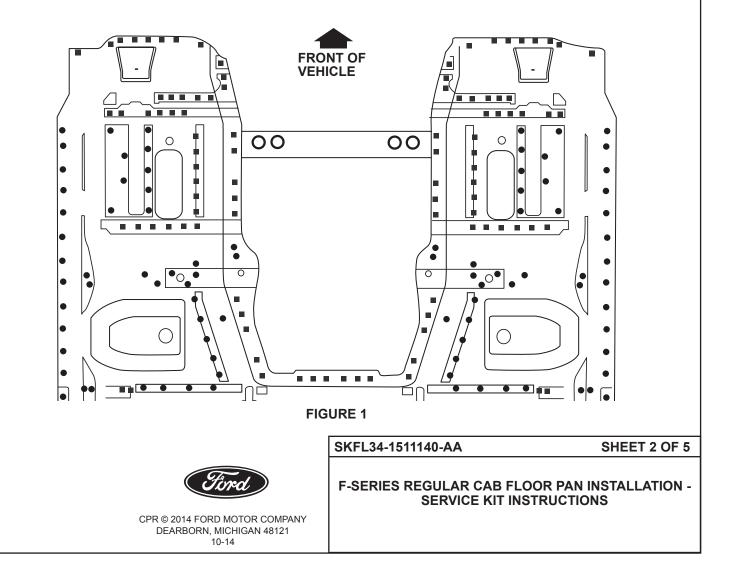
FIGURE 1 RIVET LOCATIONS

NOTE: The following are common between all cab styles.

• Black squares represent the location of the rivets (W708777-S900C)

- Eight (8) rivets (four (4) per side) to the reinforcements (15113A46/7) and the #2 crossmember (15/1610598)
- Twelve (12) rivets (six (6) per side) to sled runner (1510370/1) and torque box extension (1510024/5)
- Two (2) rivets (one (1) per side) to #1 crossmember (1510684) and sled runner (1510370/1)
- Ten (10) rivets (five (5) per side) to #1 crossmember (1510684) torque box extension (1510024/5)
- Four (4) rivets (two (2) per side) to torque box (1510414/5) and sled runner (1510370/1)
- Sixteen (16) rivets (eight (8) per side) to dash (1501610) and torque box (1510414/5)
- Six (6) rivets (three (3) per side) to floor tunnel and torque box (1510414/5)
- Black dots represent the location of the rivets (W702554-S900C)
 - Eighteen (18) rivets, (nine (9) per side next to oval slot) go to the torque box (1510414/5) and torque box extension (1510024/5).

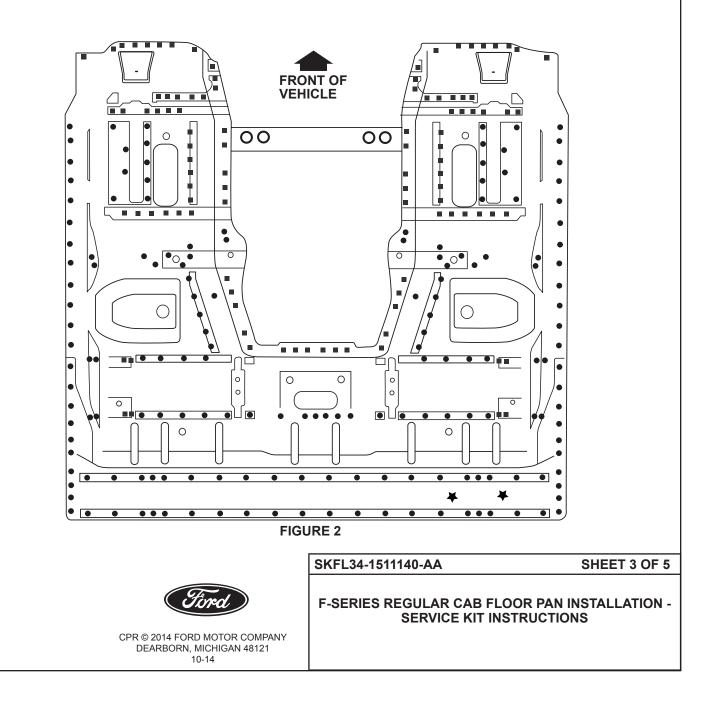
FIGURE 2 RIVET LOCATIONS

- Black dots represent the location of the blind rivets (W702512-S900C) fourty-four (44), (twenty-two (22) per side) rivets to side sill.
 - Forty (40) rivets to the rear sill (16107A94)
 - Thirty Four (34) rivets to the #2 crossmember (1610598)
 - Twelve (12) (six (6) per side) to the #1 crossmember (1510692)
 - Ten (10) rivets (five (5) per side) to the sled runners (1510370/1)
 - Eighteen (18) rivets (nine (9) per side) to the torque box extension (1510024/5)
 - Black stars represent the two (2) pierce nuts (W716819-S450) used to secure the jack.

NOTE: See the floor pan tunnel instruction sheet SKFL3 4-1511170-AA for the location and number of rivets required between them.

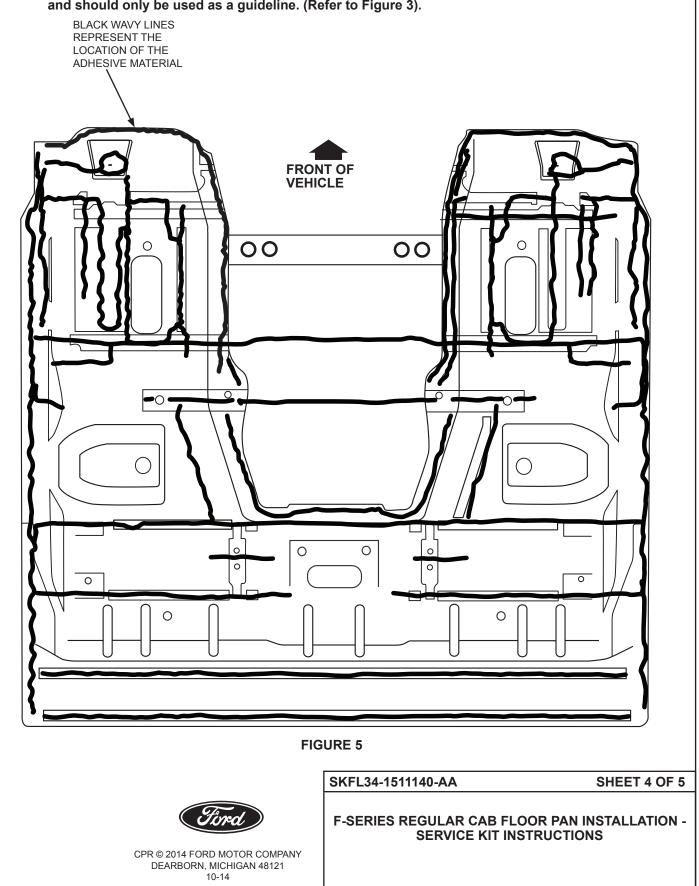
- (Refer to Figure 5) for location for adhesive material.
- NOTE: The location of SPR and adhesive shown below are based on the original production drawings and should only be used as a guideline. (Refer to Figure 3).
